## CFRP CASE STUDY

# MASONRY WALL REINFORCEMENT: BLAST LOADING UPGRADE

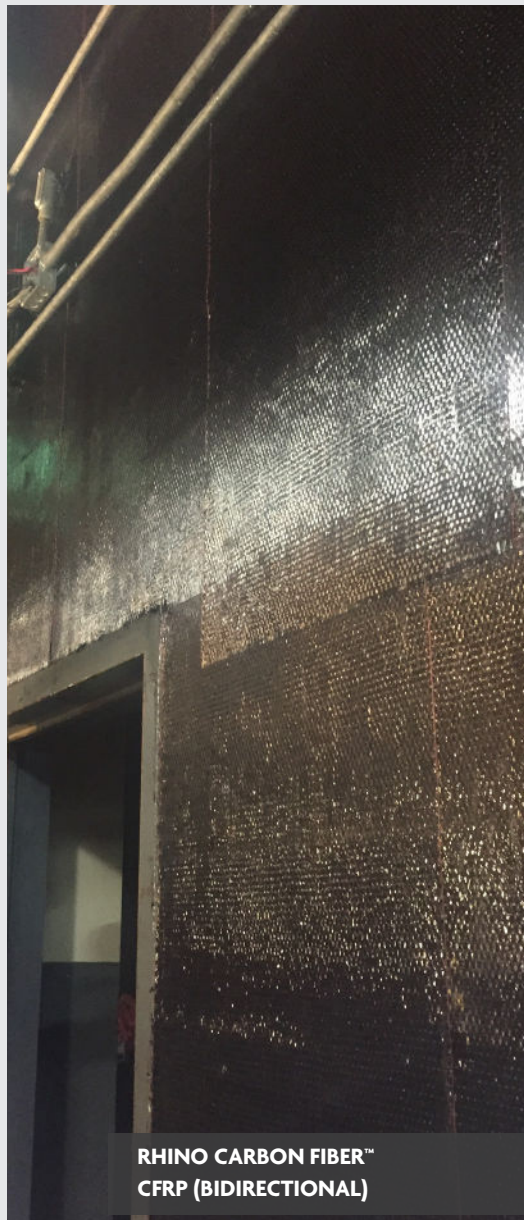
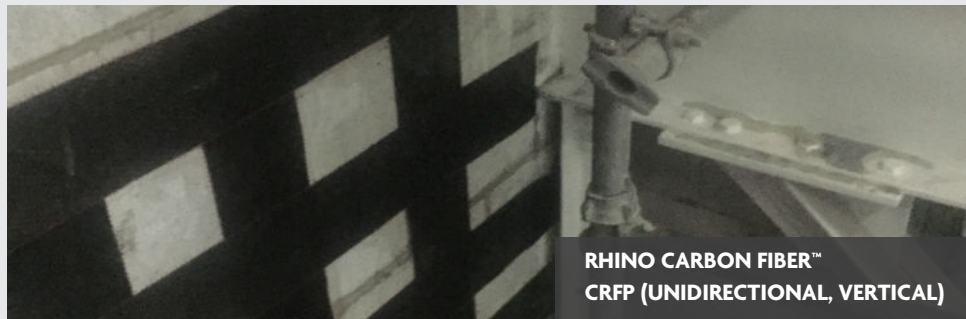
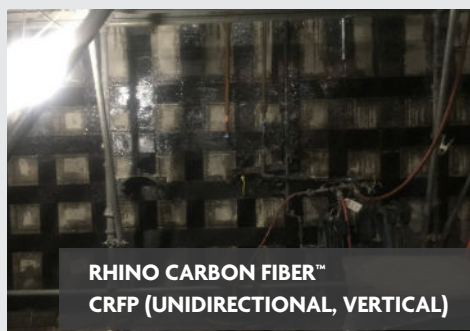
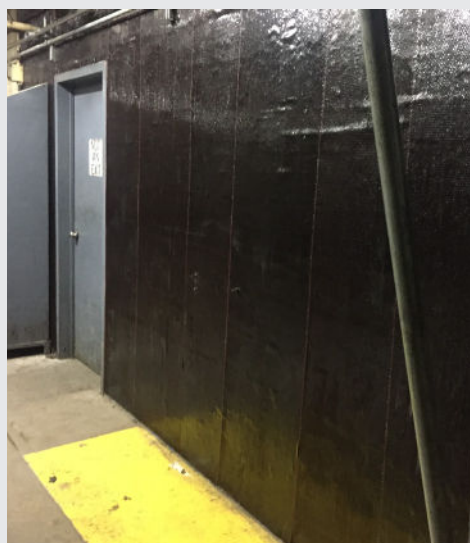
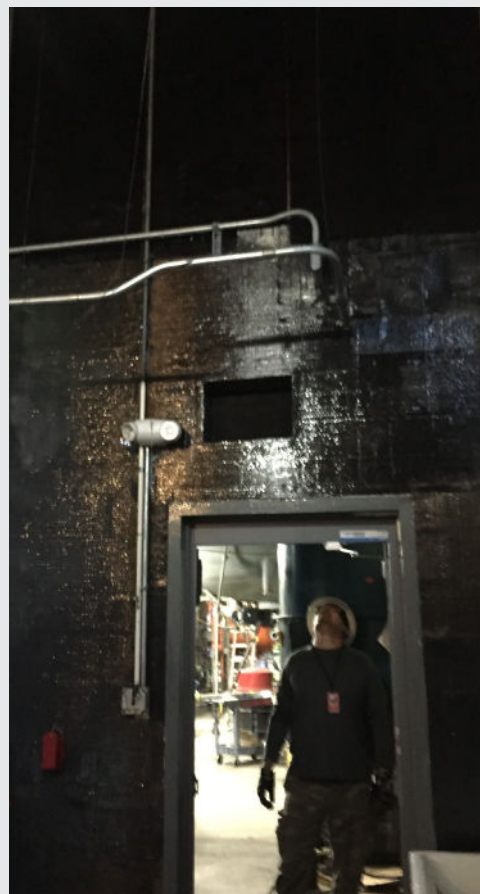
**RCF™ High Strength Anchoring Epoxy Paste** was used to seal large cracks. To strengthen the stairwell and walls to prevent dynamic cracks, 400 GSM in various widths of **Rhino Carbon Fiber™ CFRP (Unidirectional, Vertical)** and 560 GSM in various widths of **Rhino Carbon Fiber™ CFRP (Bidirectional)** were used, which were applied with **RCF™ Saturant-Adhesive Epoxy**. Different areas within the structure required different weave orientations, weights and widths to meet the requirements for the repairs.
